95-24

Ground-Penetrating Radar Investigation of the Proposed Dome- CARA Tunnel Route and Utilities at South Pole Station, Antarctica

Steven A. Arcone, Wayne Tobiasson
and Allan J. Delaney

December 1995

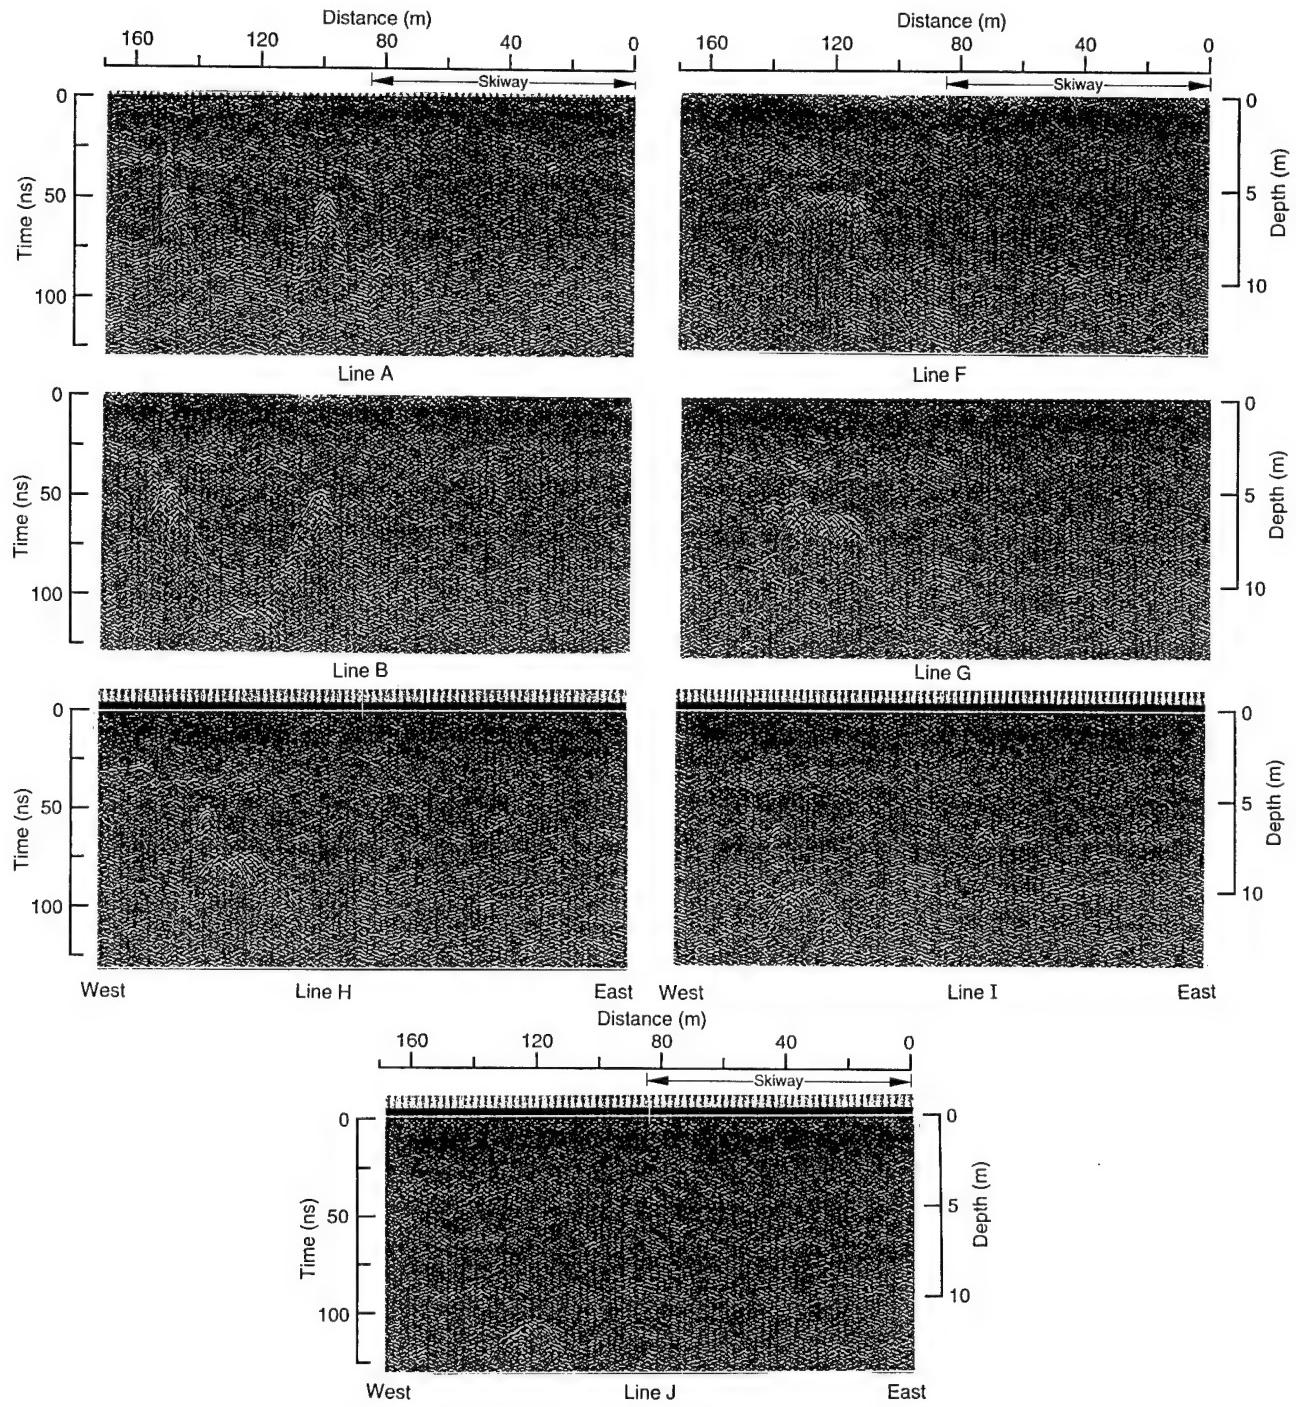
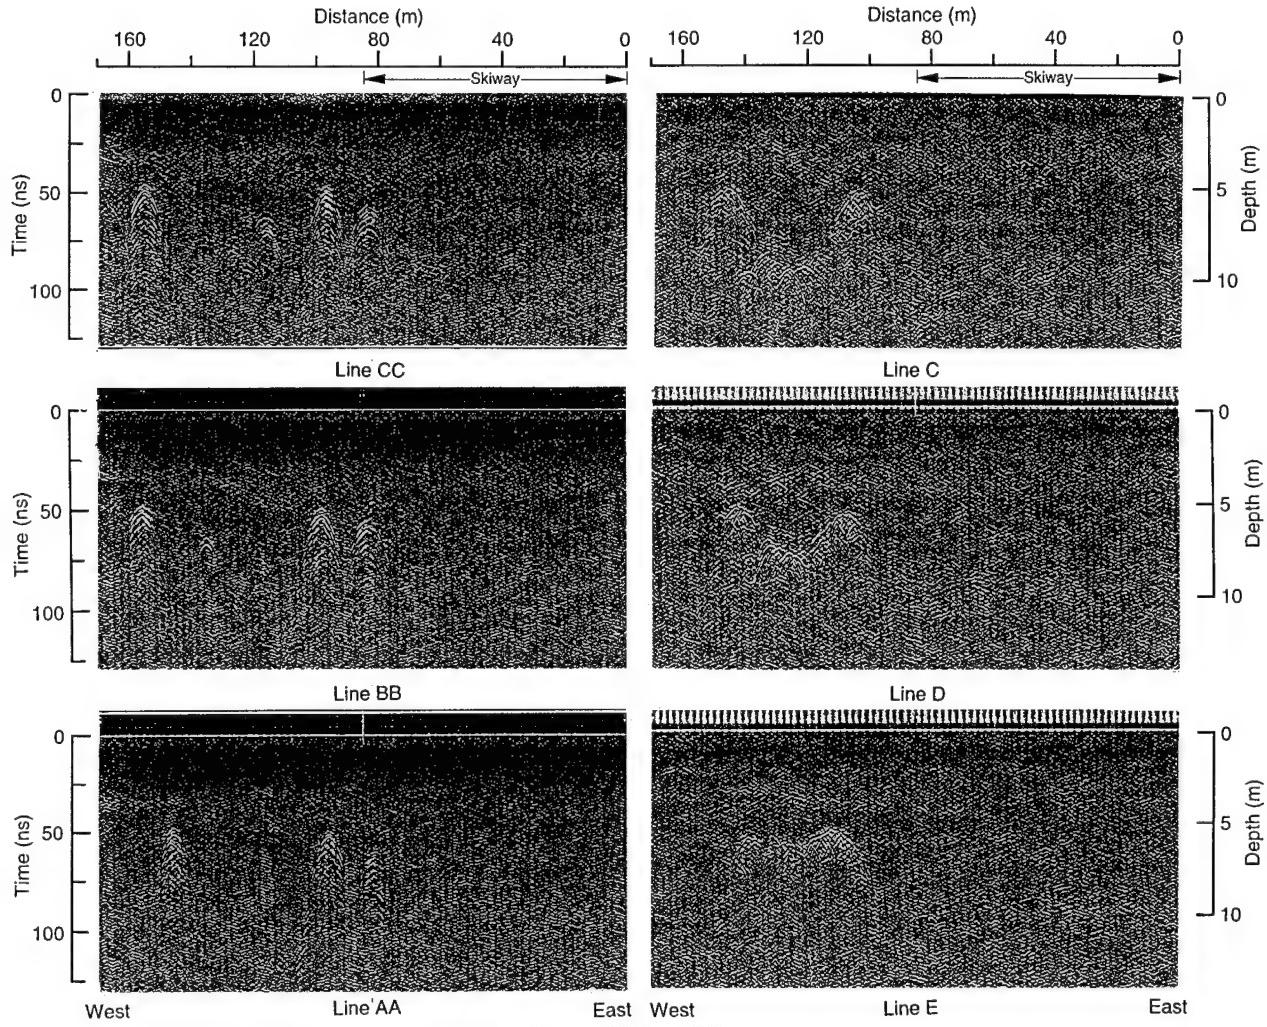
Figure 20. Segments of lines CC–J that contain the many diffractions west of the skiway. The apexes of the diffractions rise as the transects progress to the north (toward line J).

All radar profiles from line CC (southernmost line) to line J contained diffractions, with most concentrated in the 85-m-wide strip just west of the skiway. No diffractions were seen along lines K through Q in this 85-m-wide area. These 85-m-long profile segments along with the skiway itself are shown in Figure 20. Lines CC through A show responses from distinct targets. The re-

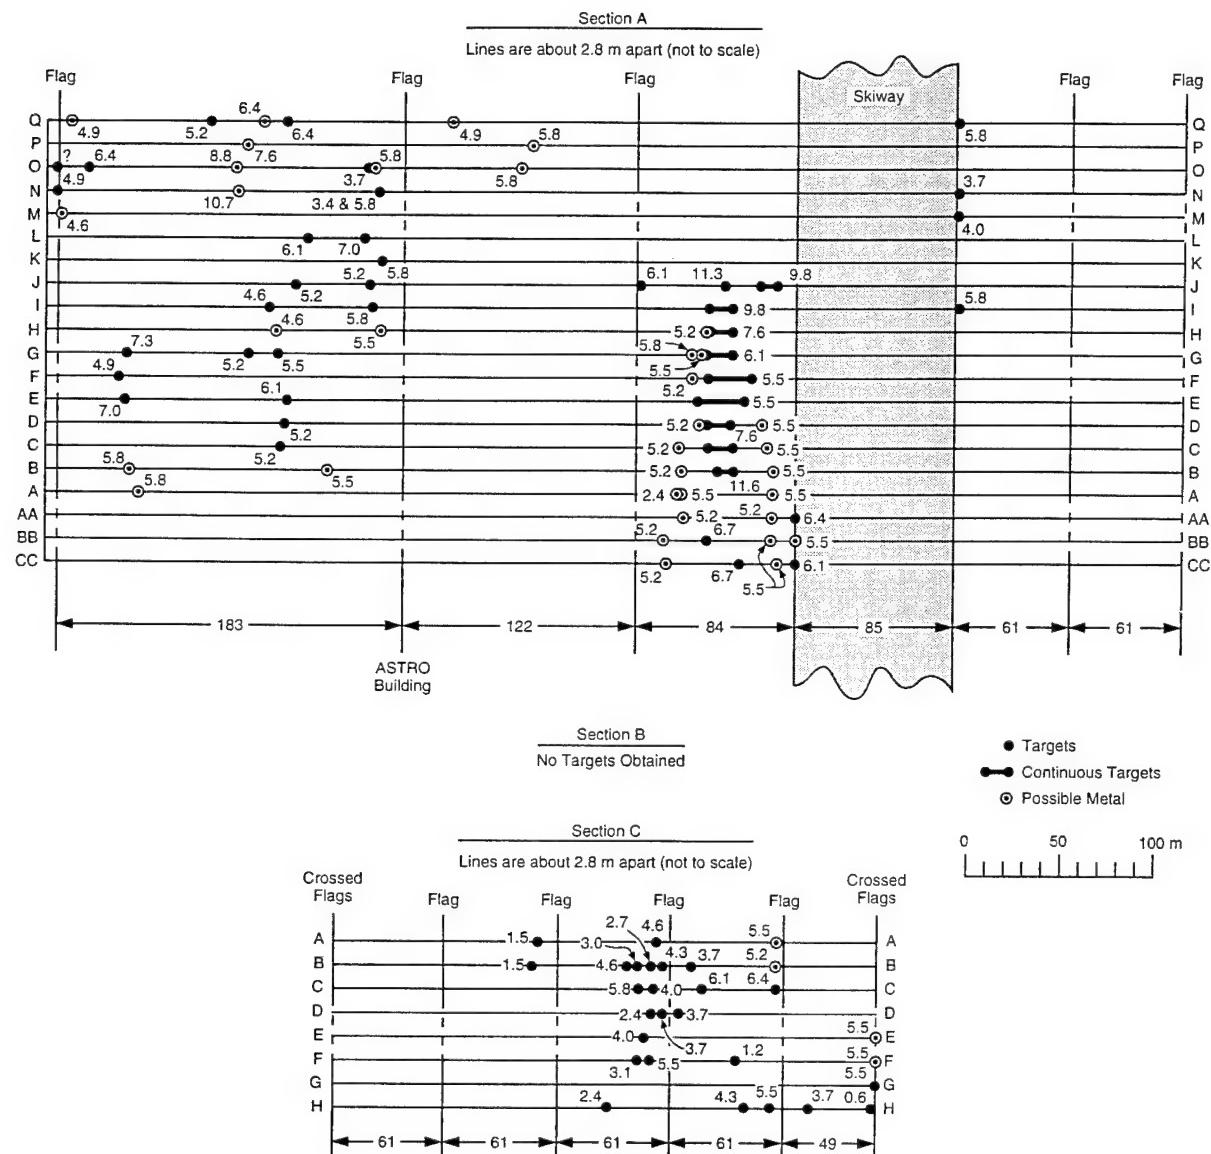
Scattered debris west of the ASTRO building is located at depths that will cause it to interfere with tunneling. However, safe routes through this area are possible. Our route surveys enabled us to find debris and assess the suitability of tunneling routes, but that work was not conducted to pinpoint the location of each potential problem. An additional radar survey for that purpose will be needed just prior to tunneling.

Figure 21. Plan view of the primary tunnel survey. Dots represent radar targets and circled dots are the more intense echoes that are probably from metal targets. Faint reflections may also be metallic targets but with a very small radar cross section. Bars (west of the runway) represent a dense continuum of targets. Numbers beside the dots and bars are depths to the targets in meters. Average line spacing is 2.8 m (not drawn to scale for clarity).

Debris just west of the skiway along the tunnel route initially proposed between ASTRO and the main station appears to be large and extensive. The tunnel should be routed just north of this area. A few objects exist in the snow along this new route, but a tunnel route can be found among them with the help of radar.

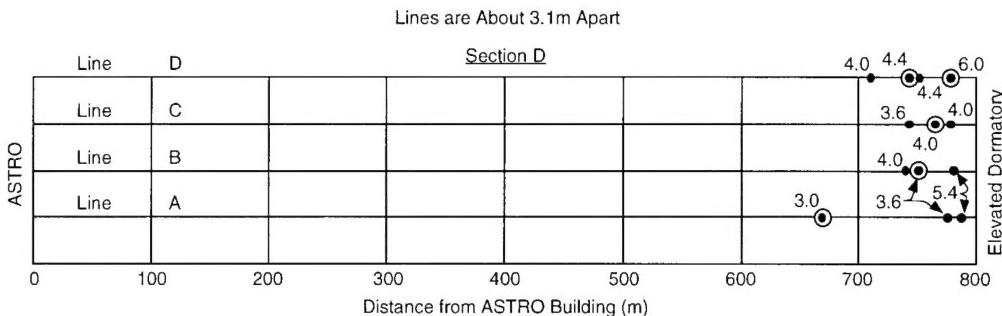
Figure 22. Plan view of the survey run between the ASTRO building and the elevated dormitory. Survey lines begin at the edge of the ASTRO building and terminate at approximately 800 m, about 10 m short of the base of the dormitory. Average survey line spacing is in meters. Dots indicate radar targets with depths in meters indicated.
